BROWN'S LAKE DAM

NDI ID NO. PA-00630
DER ID NO. 45-108

PHASE I INSPECTION REPORT
NATIONAL DAM INSPECTION PROGRAM

JUNE 1980

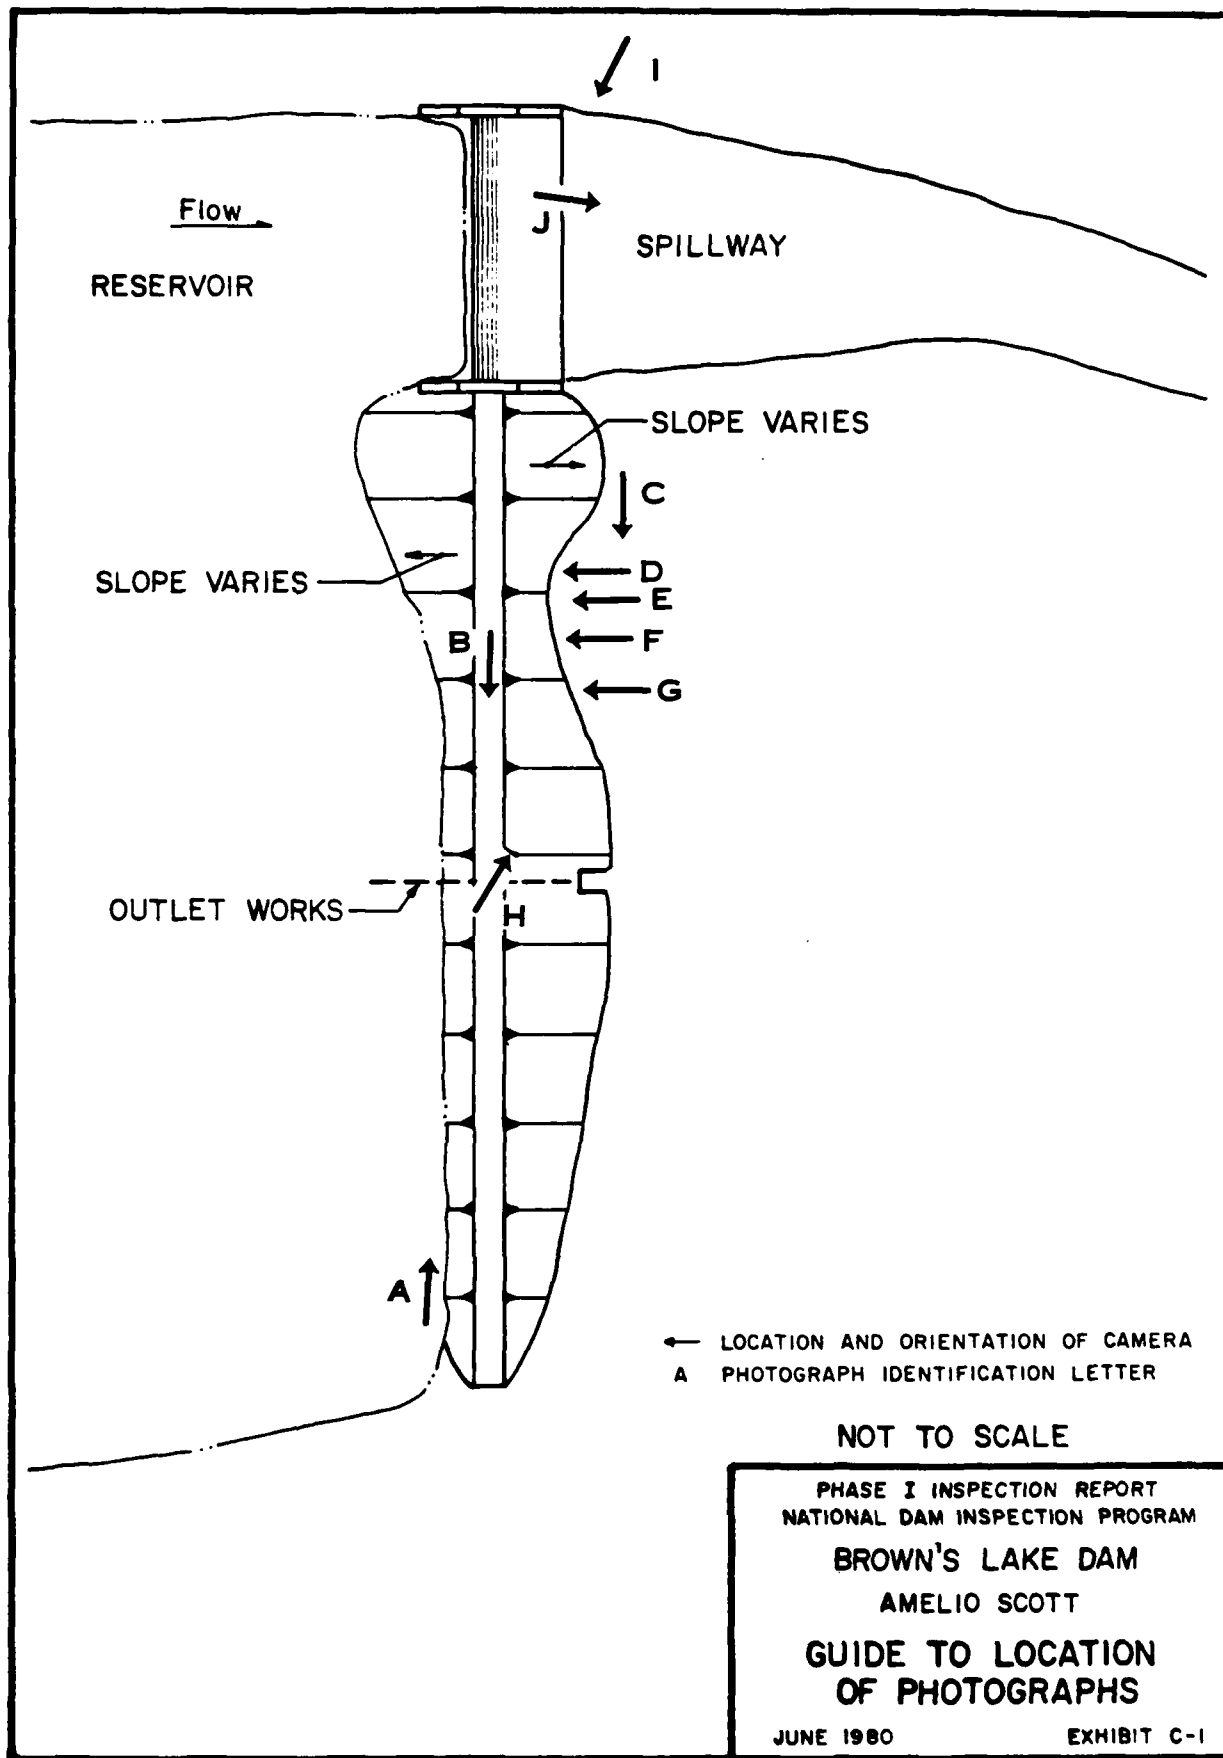
J. Spillway Outlet Channel.

c. Appurtenant Structures. The spillway is in fair condition (Photograph I). The left abutment wall has a slight, inward tilt, two cracks, and minor spalling at its base adjacent to the spillway weir. The spillway weir is a low, triangular, concrete weir. A concrete apron extends downstream from the weir for a distance of about 10 feet. Some debris was on the spillway on the day of the inspection. The weir has two areas where the concrete has cracked and spalled. Both areas are near the right end of the weir. The right abutment wall has trees and brush growing behind it. The spillway outlet channel is an excavated earthen channel (Photograph J). It appears that the channel has been subject to retrogressive erosion.
